June 2014 • Volume V • Issue VI

Published by Novogradac & Company LLP

# **Challenges and Opportunities When Redeveloping Industrial Buildings**

# 220 Water Street, Brooklyn, N.Y.

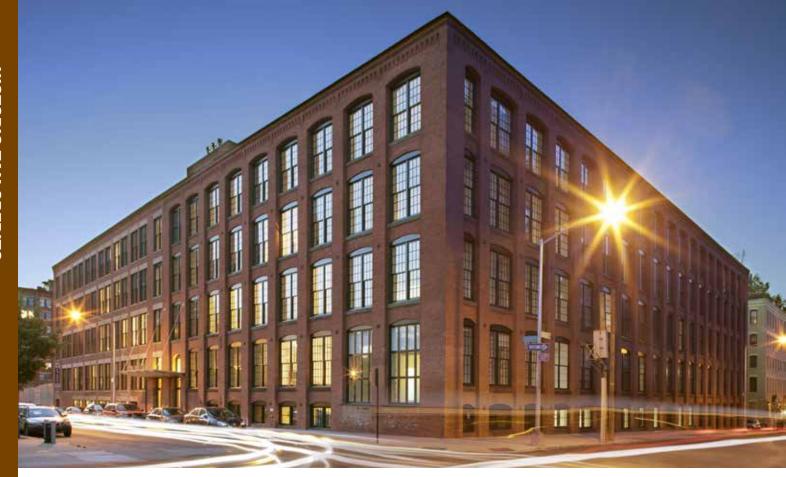
Developer GDC Properties rehabilitated 220 Water Street in the DUMBO Industrial District in Brooklyn, N.Y.

The factory consists of a circa 1893 brick and timber-frame east section and a 1905 brick and reinforced-concrete west section. Each of the two sections is U-shaped in plan, forming an open interior courtyard at the center

The developers used HTCs to rehabilitate 220 Water Street into 134 market-rate rental apartments with rents subject to New York City's stabilization regulations, along with a retail area and amenity space for tenants. On the exterior, the building's brick walls needed to be cleaned in a materially sensitive way, and the windows were in poor condition. A full window-by-window assessment of the building documented the conditions of deterioration and demonstrated the need for 100 percent replacement. While the 1893 section of the building had original windows in place, the windows in the 1905 section were replaced in the mid-20th century and no original metal sash remained. Archival research was conducted to document the historic configuration of the windows and identify an appropriate replacement window.

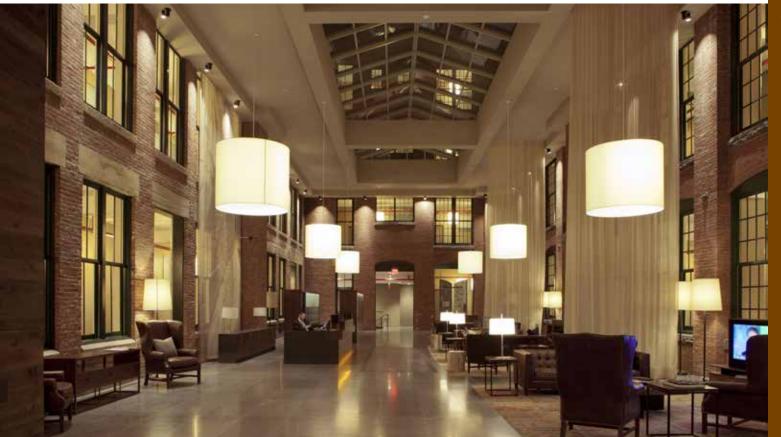
Photo: Courtesy of © Sean Hemmerle 2012 Reprinted with permission The property at 220 Water Street had housed the the Hanan & Son Shoe Company's shoe factory.
