Novogradac Journal of Tax Credits

HISTORIC TAX CREDIT TOOL BOX

Assembling an Effective Team for Window Replacement on Historic Tax Credit Projects

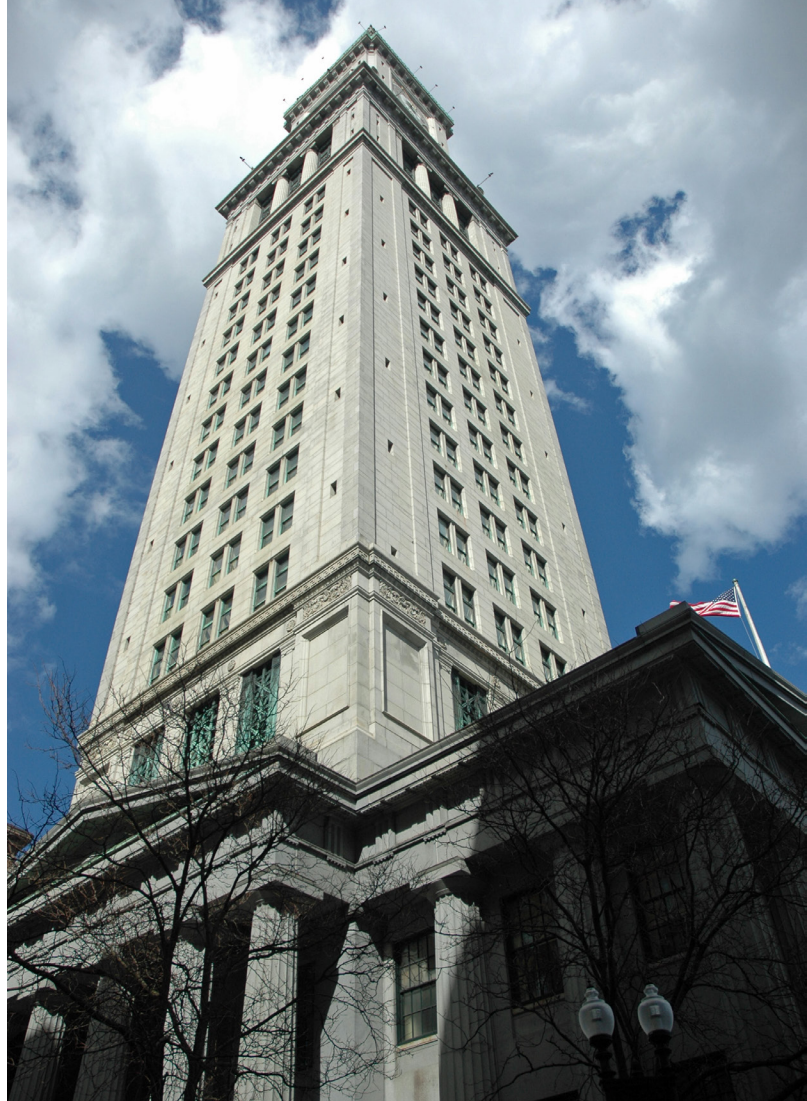
Boston's Custom House included the restoration of copper-clad wood windows in the upper floors and replication of fenestration in aluminum in the lower floors.

This type of teamwork led to a highly custom response on Boston's Custom House. The architectural firm of Jung Brannen engaged the services of a manufacturer's representative with building experience and an architectural background. The project, which utilized HTCs, involved the restoration of copper-clad wood windows at the upper floors and a replication of that fenestration in aluminum at the building's two-story base, where the historic material had been unsympathetically replaced.

With photographic backup, a contour gauge survey was conducted on one of the few remaining lower-floor, copper-clad windows. An aluminum manufacturer was encouraged to create custom extrusions to replicate the specific the brick mold and blind stop and also to provide custom extrusions for a true divided light that faithfully replicated the appearance of the historically significant sections.

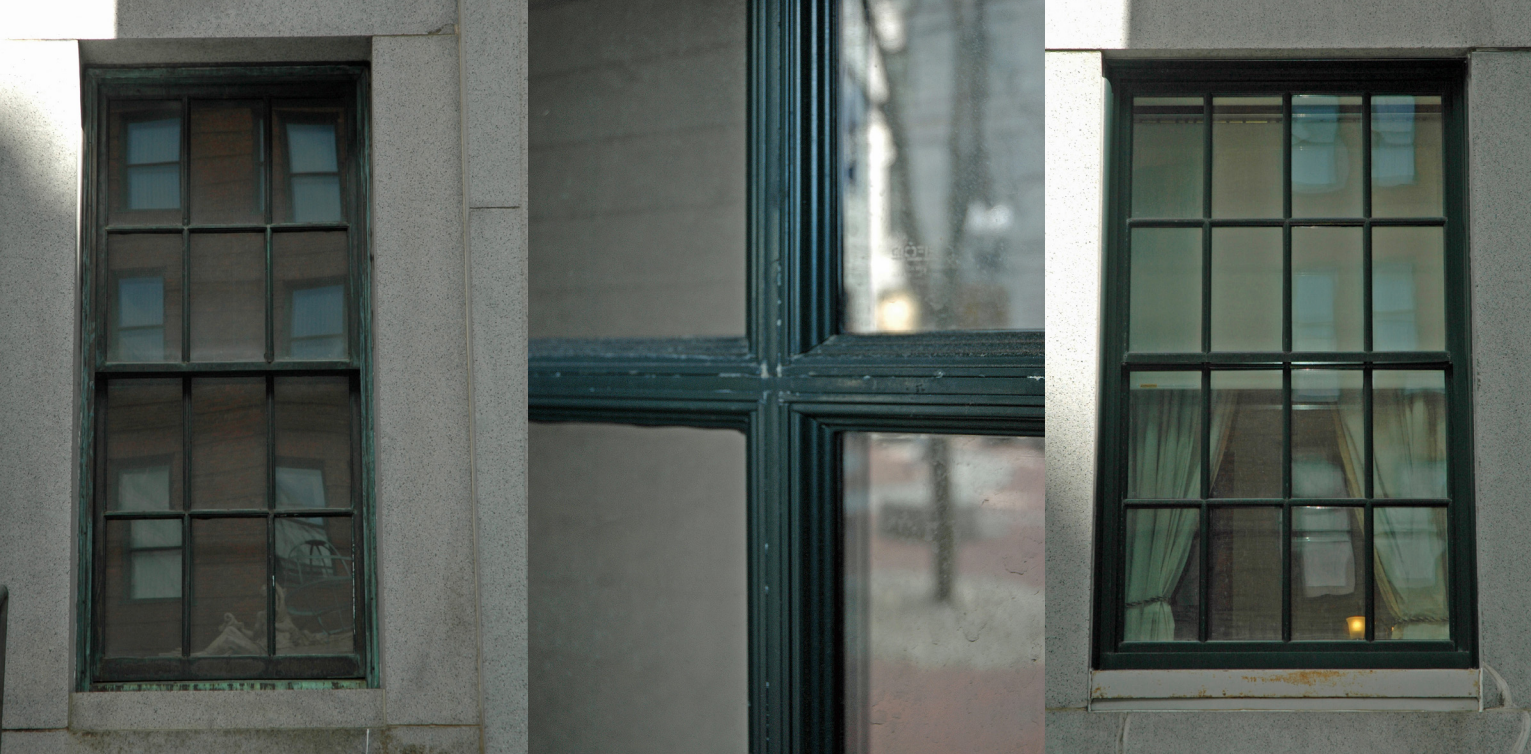
Photo 1. The windows on Boston's Custom House required photographic backup to help guide restoration on the upper floors, replication on the lower floors. **Photos 2-3.** Boston's Custom House featured the restoration of both the copper-clad wood windows on the upper floors and a replication of fenestration in aluminum in the building's two-story base.
